EcoStar_® & EcoStar SVRS_®

Troubleshooting Guide

SP3400VSP & SP3400VSPVR

Drive r1.13 Interface r3.0.8 residential Interface r3.0.8C commercial

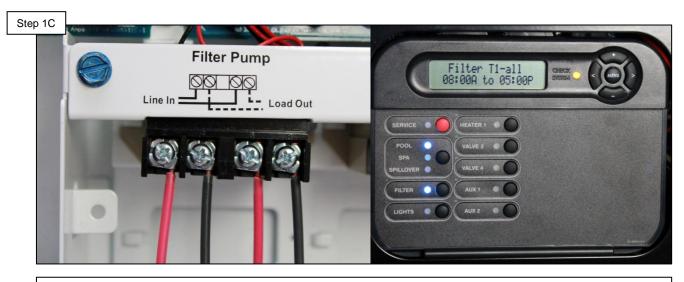
When connected to Hayward Automation, automatically clear error daily by wiring the pump to the load side of the 'filter' relay (do not disrupt low voltage wiring):

Wire the pump to the 'filter' relay and set timers in the automation system as desired. Keep in mind, the EcoStar must be powered down for at least 1 minute every 24 hours.

Note: This solution will cause a 'Bridge Comm Error' on the controller. This expected error indicates that the pump is not communicating while powered down; this error will clear when pump's power is restored. Please inform customer prior to employing this solution.

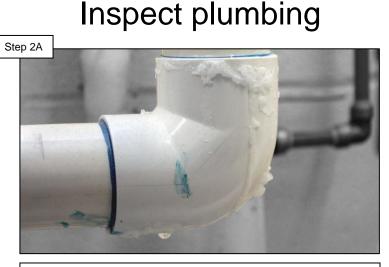
Verify there are no air leaks on suction side plumbing. If no air leaks, go to step 2B. If air leaks exist, repair plumbing and retry prime.

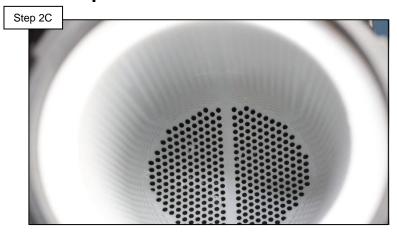
Inspect baskets & filter

Inspect filter, skimmer, and pump baskets for obstructions or debris. Clean filter and clear all debris, then retry. If prime fails go to step 2D.

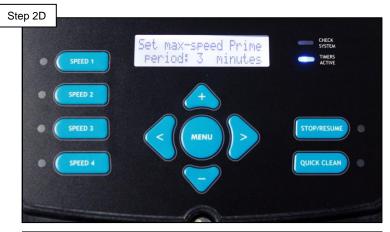
Remove 'Auto Prime'

Remove pump from Auto Prime mode and set for 3 minute prime (or higher) to eliminate the fail to prime error, follow steps on next page.

Plumbing less than 2" in diameter may cause flow restrictions great enough to inhibit Auto Prime from working properly. If diameter is less than 2" setting the pump to 3 minute prime (or higher) is recommended.

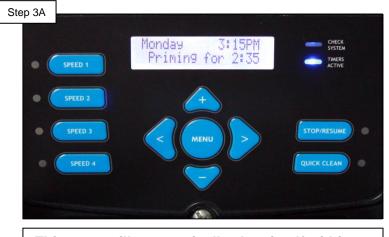
Automatic clear

This error will automatically clear itself within 20 seconds of the outage. To manually clear proceed to step 3B.

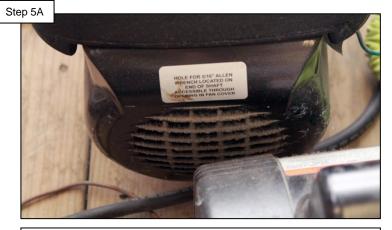
Check motor airflow

Inspect the airflow path, verifying the pump is receiving ample air supply. Check entire air path and clear any obstructions/debris, then go to 5B.

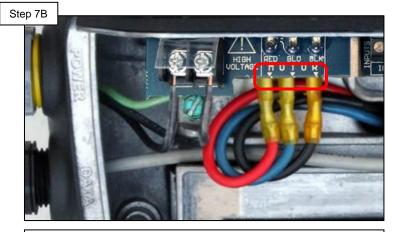
Check connections

Check the three connections between the drive and the motor, verifying that they are tight on the drive. If connections are correct, replace the drive and go to step 7C.

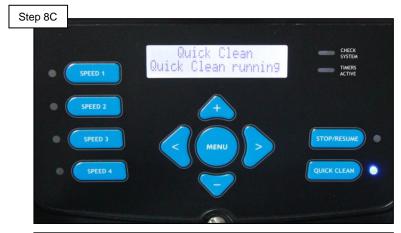
Run with new drive

With replacement drive run the pump on quick clean for a minimum of 20 minutes to verify the motor has not suffered any damage. If stall reoccurs, replace the motor as well.

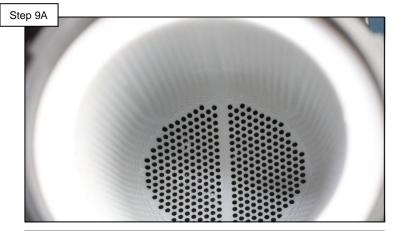
Inspect baskets & filter

Inspect filter, skimmer, and pump baskets for obstructions or debris. Clean filter and clear all debris, then retry. If failed again go to step 8B.

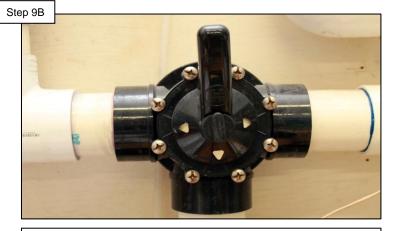
Monitor valves

Eliminate or divert features that may change vacuum pressures (such as: automatic cleaning, solar, etc.). If using controls, go to step 8C.

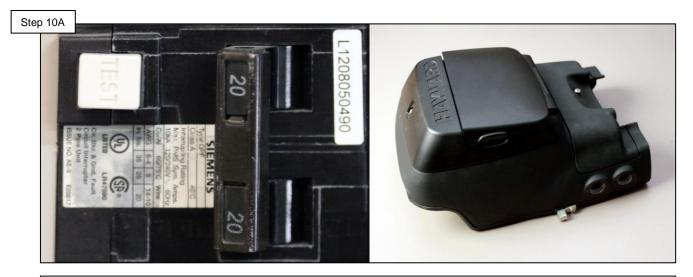
Shut off breaker supplying EcoStar with power for at least 2 minutes, then restore power. If error appears again replace the drive.

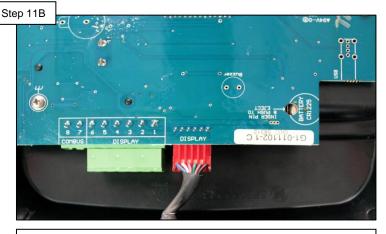
Inspect harness

Verify the wiring harness is connected snugly and inspect wires for damage. If damaged, replace drive; If not, go to step 11C.

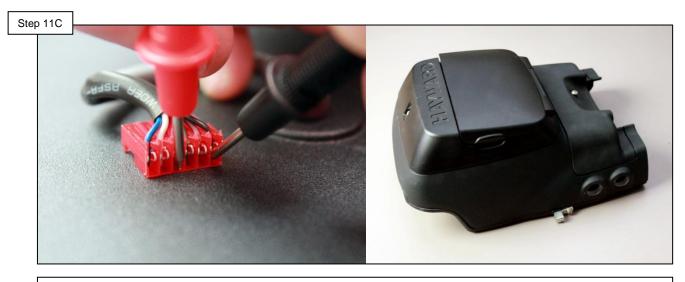
Test display input

With pump powered on, check voltage on display for value 9-15VDC between 1(-) & 4(+) (right to left) on wiring harness. If correct, replace display only, if below 9VAC – check AC mains power for value above 200VAC, if ZERO replace drive.

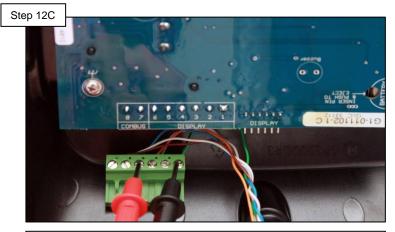
Display comm power

Check voltage on display for 9-15VDC between 1-4 (right to left) on RS485. If correct, replace display only, if no/low go to step 13D.

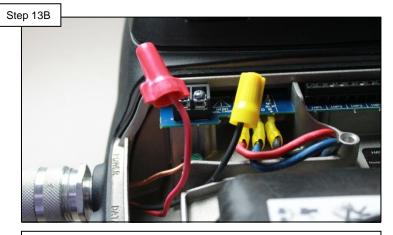
Disconnect power wires

Disconnect power from mains and engage breaker. If breaker does not trip go to 13C, if breaker trips, wiring has short OR bad breaker.

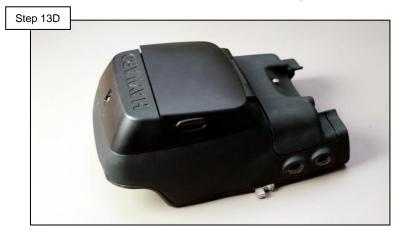
Check breaker type and all connections. If breaker health and connections are confirmed and problem still exists, replace drive.

Note: In cases where a GFCI breaker experiences nuisance trips (despite confirming the pump and circuit are in good health), the Siemens QF220 has proven effective.
